<b>A. SPCC FIELD SHEET</b> (To be completed if SPCC Regulation is applicable to Facility - See 40 CFR 112.1)				
1a. NAME OF FACILITY Clark Oil Refinery			1b. TYPE OF FACILITY Oil Refining	
1c. FACILITY LOCATION 131st & Kedzie, Blue Island, Cook County, Illinois 60406, 41° 39' 19" N, 87° 42' 27" W				
2a. NAME OF OWNER AND/OR OPERATOR RESPONSIBLE FOR FACILITY Clark Refining & Marketing, Inc.			2b. TELEPHONE NUMBER (708)385-5000	
2c. MAILING ADDRESS 131st & Kedzie, Blue Island, Illinois 60406

## B. SPCC INSPECTION SUMMARY SHEET

**C. DETAILED SPCC DOCUMENTATION****FACILITY**  
Clark Refining & Marketing, Inc.**DATE OF INSPECTION****1. FACILITY DESCRIPTION****1a. TYPE OF BUSINESS/OPERATION**  
Oil refining.**1b. FACILITY OIL STORAGE**

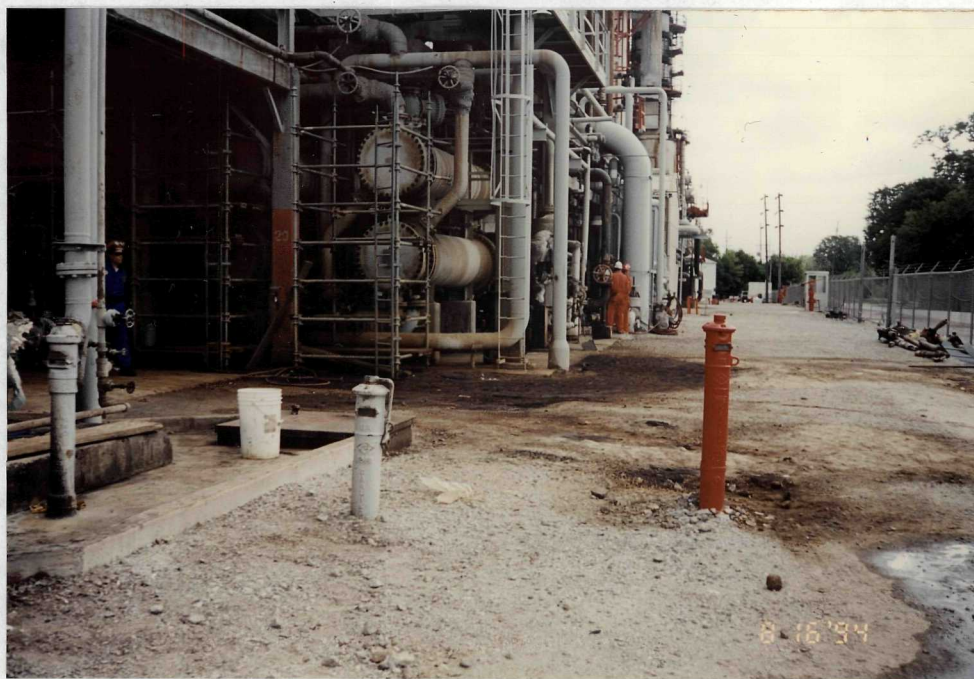
- There were visible oil stains on the soil especially in the process areas.
- Rain that accumulated in the diking was not promptly drained. In one dike area, oil sheen was visible.

C. DETAILED SPCC DOCUMENTATION					
7. PHOTOGRAPHS (Attach more sheets if needed)					
<b>SUBJECT</b> Soil stains evident in some areas of the process section of the facility.					
<b>FACILITY</b> Clark Oil Refinery					
<b>PHOTOGRAPHER</b> Jane G. Malkin				<b>WITNESSES</b> Todd Ramaly	
<b>DATE</b> August 16, 1994	<b>TIME</b> 1100 hours	<b>DIRECTION</b>	<b>CAMERA</b> Olympus Infinity	<b>FILM</b> 35mm	<b>ATTACHMENTS</b>

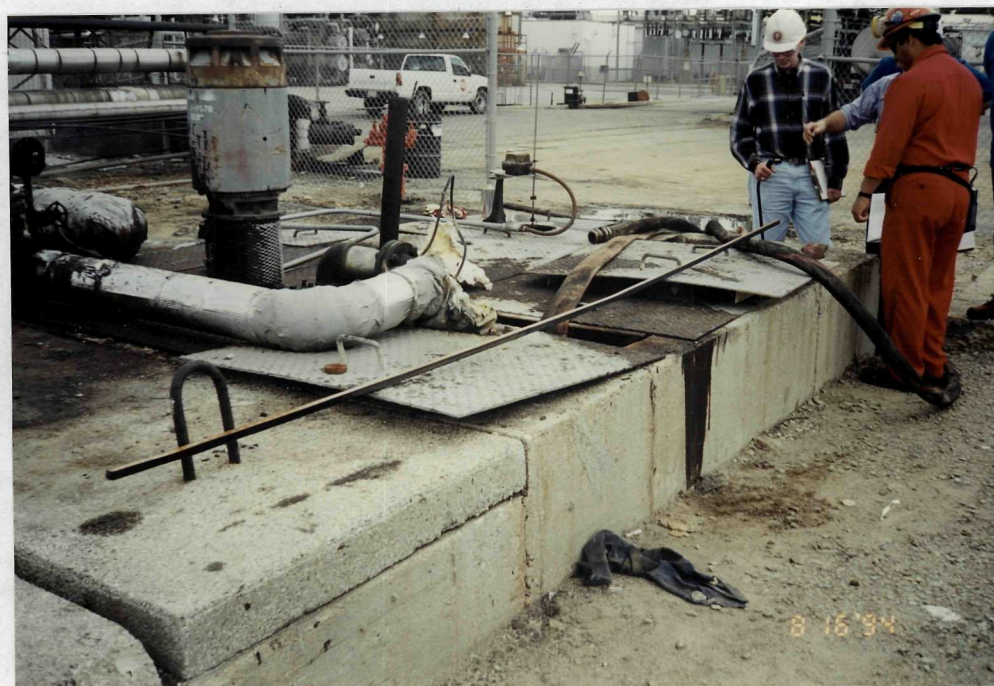
<b>C. DETAILED SPCC DOCUMENTATION</b>					
<b>7. PHOTOGRAPHS (Attach more sheets if needed)</b>					
<b>SUBJECT</b> 38 Junction Box - weir separator for process drains and storm drain.					
<b>FACILITY</b> Clark Oil Refinery					
<b>PHOTOGRAPHER</b> Jane G. Malkin			<b>WITNESSES</b> Todd Ramaly		
<b>DATE</b> August 16, 1994	<b>TIME</b> 1145 hours	<b>DIRECTION</b>	<b>CAMERA</b> Olympus Infinity	<b>FILM</b> 35mm	<b>ATTACHMENTS</b>

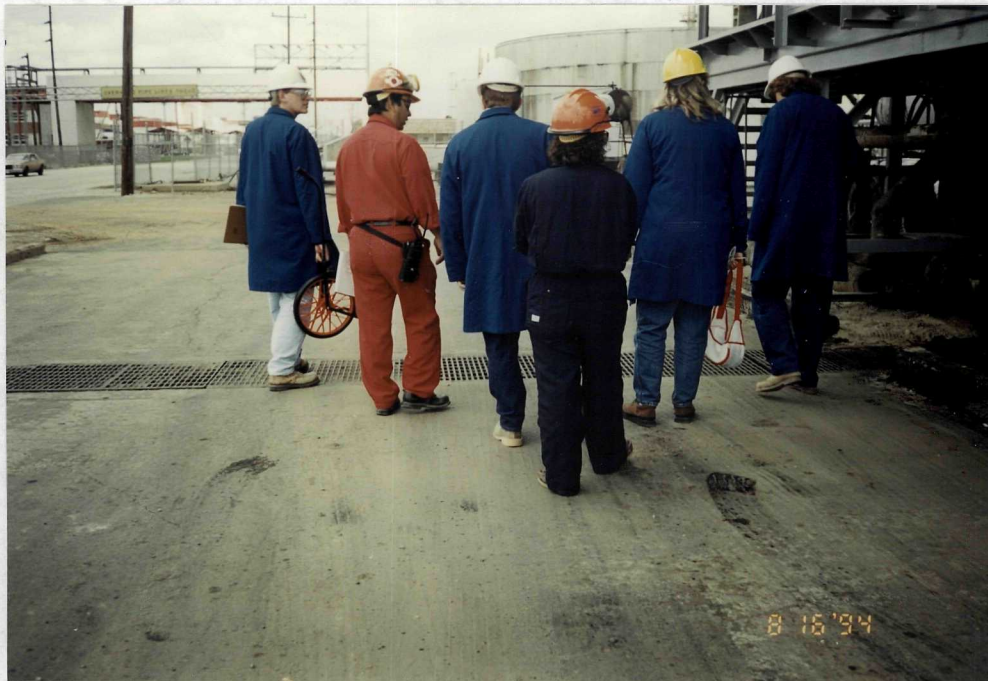
<b>C. DETAILED SPCC DOCUMENTATION</b>					
<b>7. PHOTOGRAPHS (Attach more sheets if needed)</b>					
<b>SUBJECT</b> Drainage under the loading rack. The drainage connects to the storm sewer.					
<b>FACILITY</b> Clark Oil Refinery					
<b>PHOTOGRAPHER</b> Jane G. Malkin			<b>WITNESSES</b> Todd Ramaly		
<b>DATE</b> August 16, 1994	<b>TIME</b> 1150 hours	<b>DIRECTION</b>	<b>CAMERA</b> Olympus Infinity	<b>FILM</b> 35mm	<b>ATTACHMENTS</b>

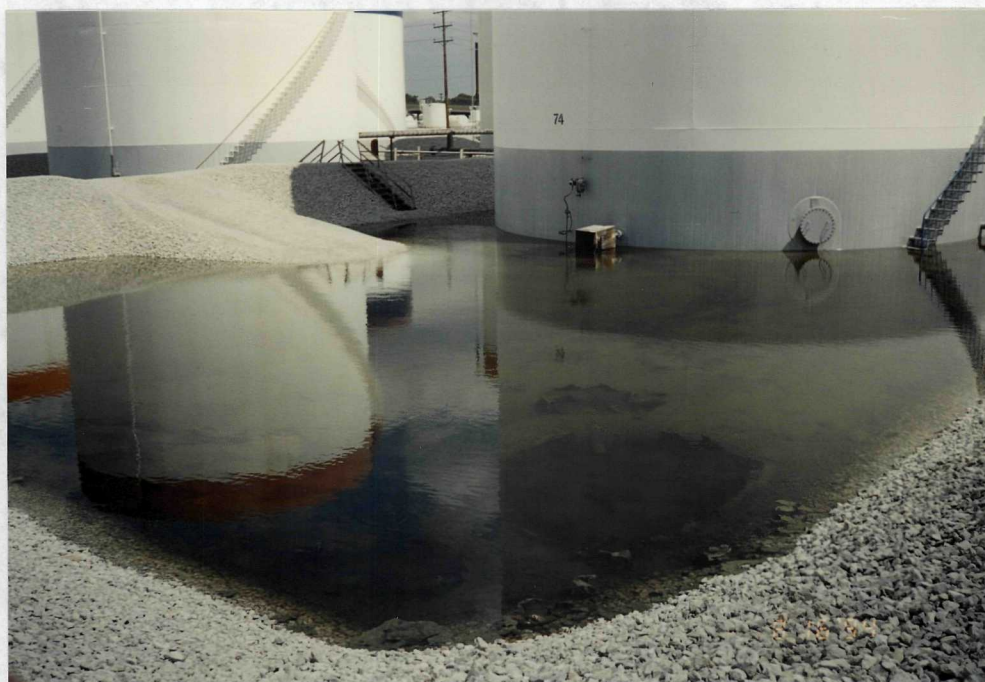
<b>C. DETAILED SPCC DOCUMENTATION</b>					
<b>7. PHOTOGRAPHS (Attach more sheets if needed)</b>					
<b>SUBJECT</b> Water that accumulated in the dikes after the rain.					
<b>FACILITY</b> Clark Oil Refinery					
<b>PHOTOGRAPHER</b> Jane G. Malkin				<b>WITNESSES</b> Todd Ramaly	
<b>DATE</b> August 16, 1994	<b>TIME</b> 1215 hours	<b>DIRECTION</b>	<b>CAMERA</b> Olympus Infinity	<b>FILM</b> 35mm	<b>ATTACHMENTS</b>

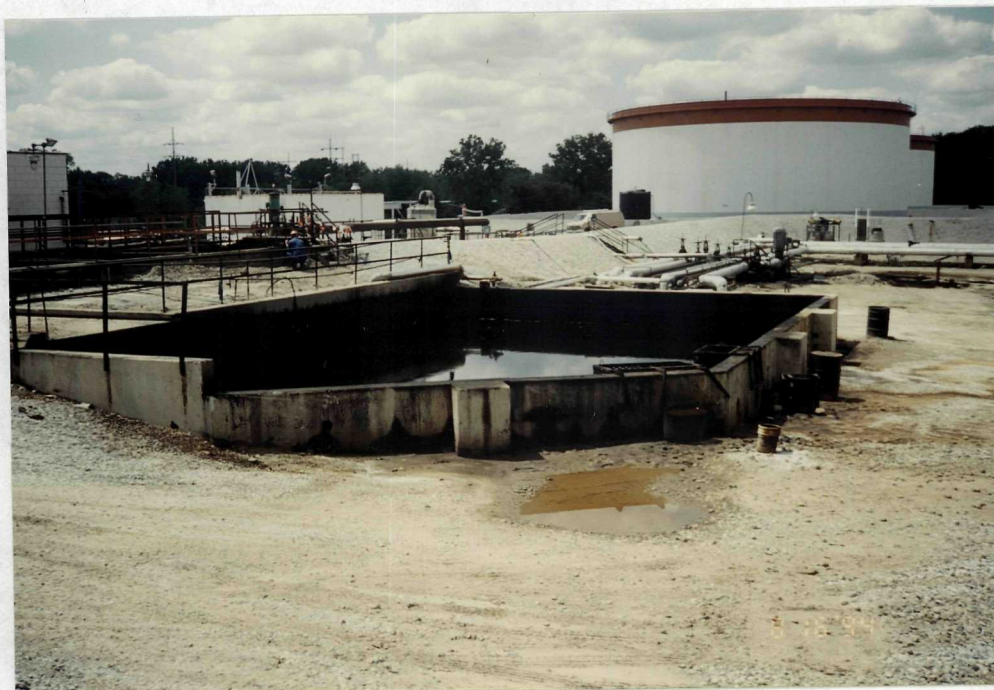
<b>C. DETAILED SPCC DOCUMENTATION</b>					
<b>7. PHOTOGRAPHS (Attach more sheets if needed)</b>					
<b>SUBJECT</b> Holding tank for overflow from the water treatment system.					
<b>FACILITY</b> Clark Oil Refinery					
<b>PHOTOGRAPHER</b> Jane G. Malkin				<b>WITNESSES</b> Todd Ramaly	
<b>DATE</b> August 16, 1994	<b>TIME</b> 1230 hours	<b>DIRECTION</b>	<b>CAMERA</b> Olympus Infinity	<b>FILM</b> 35mm	<b>ATTACHMENTS</b>

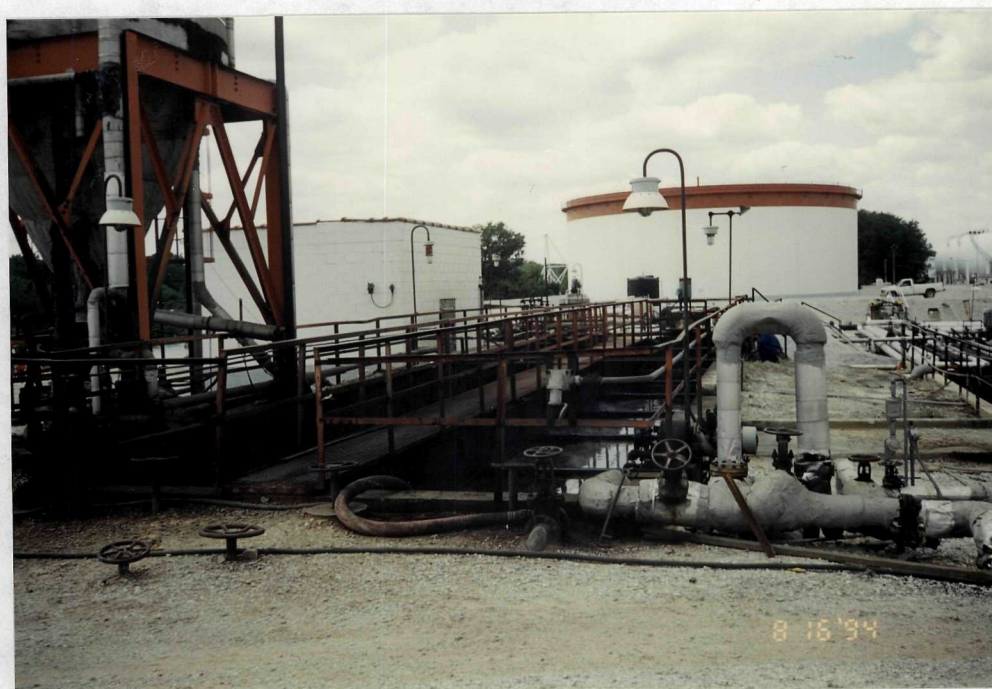
<b>C. DETAILED SPCC DOCUMENTATION</b>					
<b>7. PHOTOGRAPHS (Attach more sheets if needed)</b>					
<b>SUBJECT</b> Water treatment system.					
<b>FACILITY</b> Clark Oil Refinery					
<b>PHOTOGRAPHER</b> Jane G. Malkin				<b>WITNESSES</b> Todd Ramaly	
<b>DATE</b> August 16, 1994	<b>TIME</b> 1220 hours	<b>DIRECTION</b>	<b>CAMERA</b> Olympus Infinity	<b>FILM</b> 35mm	<b>ATTACHMENTS</b>

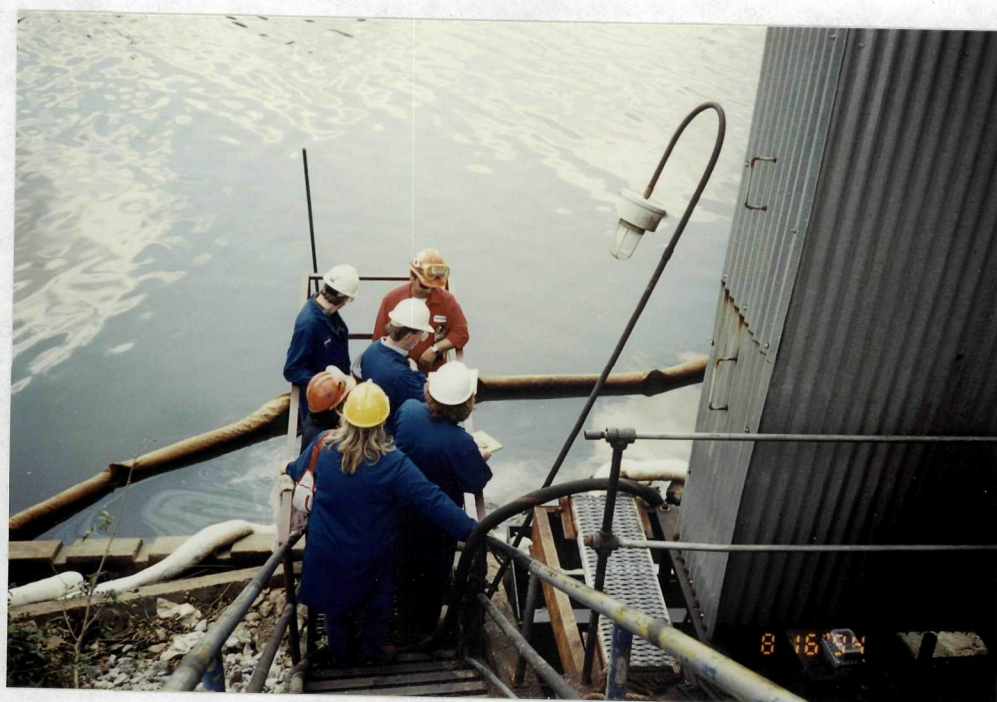
<b>C. DETAILED SPCC DOCUMENTATION</b>					
<b>7. PHOTOGRAPHS (Attach more sheets if needed)</b>					
<b>SUBJECT</b> Outfall to the Calumet-Sag Channel.					
<b>FACILITY</b> Clark Oil Refinery					
<b>PHOTOGRAPHER</b> Jane G. Malkin				<b>WITNESSES</b> Todd Ramaly	
<b>DATE</b> August 16, 1994	<b>TIME</b> 1230 hours	<b>DIRECTION</b>	<b>CAMERA</b> Olympus Infinity	<b>FILM</b> 35mm	<b>ATTACHMENTS</b>
